Bearing Damage Resulting from Shaft Voltages and Currents

By: David Kowal, Application Development Engineer

© Computational Systems Incorporated, 1999

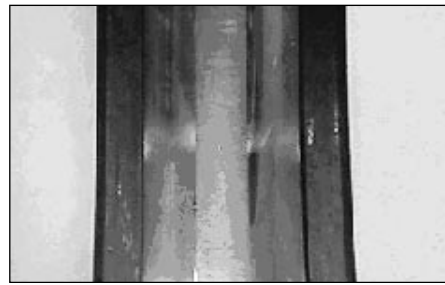
Figure 5. Bearing outer race with frosting

Frosting has a symmetrically sandblasted or machined appearance. Figure 5 shows a picture of an outer race with frosting. Notice how the center section is shaded differently than on either side of it. When viewed microscopically, the frosted surface is seen as very small individual craters. The bottoms of the craters are round and shiny, indicating melting due to the electrical discharge. Frosting may be mistaken for chemical damage, but its craters are smaller in size and dull in appearance.²

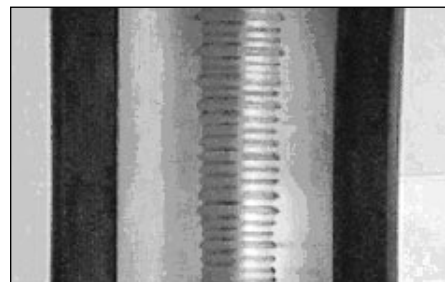
Figure 6. Bearing outer race with fluting

of being machined, thereby making it the easiest to identify as a sign of EDM. The flutes are very narrow and closely spaced.⁹ This is often described as having a washboard appearance. Figure 7 shows a fluted outer race with spalling.

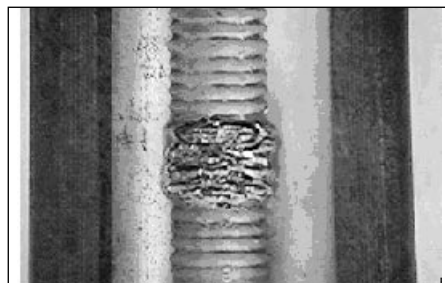
Figure 7. Fluted outer race advancing into spalling

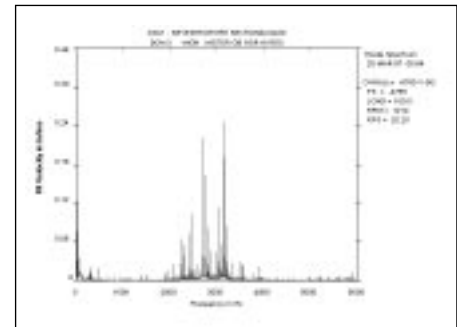
Figure 8. High frequency spectrum showing fluting

acquired on the outboard bearing of a 400 HP / 500 volt DC motor using a 6000 Hz Fmax and 3200 lines of resolution. Some PdM programs only acquire data out to 2000 Hz or less and miss the high frequency energy resulting from fluted bearings. This mound of energy

As shown in Figures 8 and 9, this type of fault in its early stages doesn't show regular bearing fault frequencies in the lower frequency ranges. As the bearing fault worsens due to normal bearing degradation, the regular bearing fault frequencies will show up in the lower frequency range.

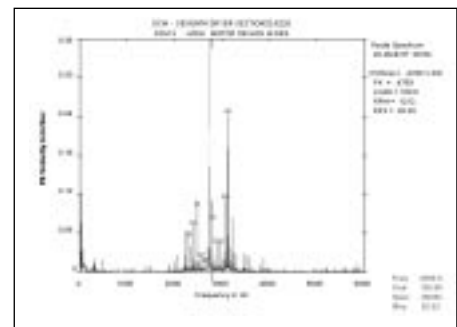
Figure 9. High frequency spectrum showing fluting with BPF0 sidebands

will have sidebands of either BPFO, BPFI, or a combination of both. The most common sidebands are BPFO, as in Figure 9.

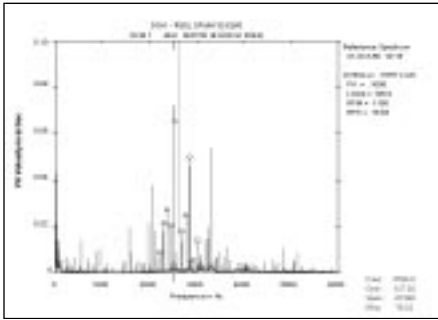
Figure 11. Vibration data acquired 31-OCT-96

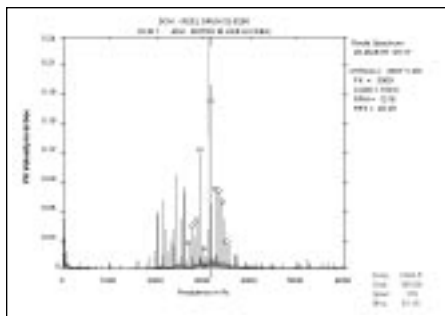
Figure 12. Vibration data acquired 20-MAR-97

increase in the vibration level in the upper frequency range since the data was acquired in Figure 11. Also as the problem worsens, Figure 14 shows an increase in the AC RMS voltage and peak voltage levels since the data

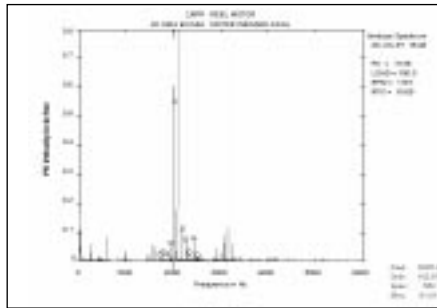
Figure 15. Vibration data acquired 29-JUL-97 (last measurement before shutdown). Notice the amplitude scale is twice that of Figure 12.

Figure 15, acquired in the axial direction on the inboard bearing, shows the vibration level of the motor just before it was replaced. Figure 16 shows the shaft voltage and current levels. Note the AC RMS voltage and peak voltage levels have dropped slightly since the last measurement. The current levels still appear to be unchanged.

When the inboard bearing was pulled, the outer race showed signs of fluting in its load zone, and the inner race and balls showed signs of frosting. The motor was replaced with an identical motor with a shaft grounding system. Figure 17 and 18 show the vibration and shaft voltage/current data acquired on it after it was installed. Notice the lower levels. Even though this is a different motor, the vibration data shows no evidence of EDM, and the AC RMS voltage and peak voltage levels have dropped off considerably.

Replacing just the motor only might have solved their problem, but since replacement motors without shaft grounding systems didn't solve EDM problems in the past, installing a shaft grounding system was probably the correct alternative action to take. The replacement motor will continue to be monitored to determine how effective the shaft grounding system is in reducing the damage due to EDM.

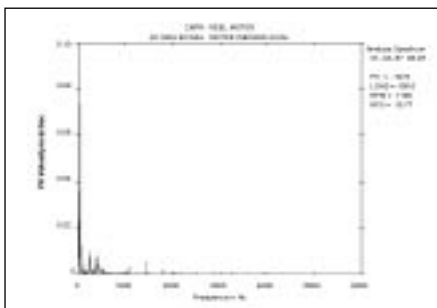
Figure 17. Vibration data acquired 31-JUL-97 (first measurement after shutdown)

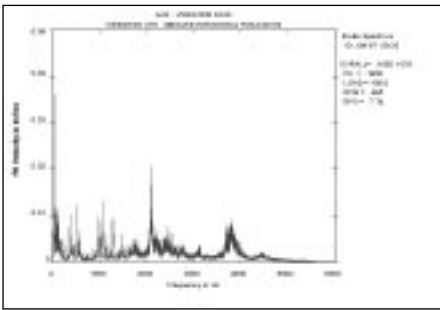
Figure 19. Vibration data acquired while process ran at 457 RPM

The CSI Model 2120, with a 100 mV/g accelerometer, was used to acquire vibration data and the CSI UltraSpec 8000 and Model 348SP shaft probe was used to acquire the shaft voltage and current data. Vibration data was acquired on both the inboard and outboard bearings in the horizontal direction, as the motor ran at 457 RPM. Figure 19, taken on the inboard bearing, doesn't show the mound

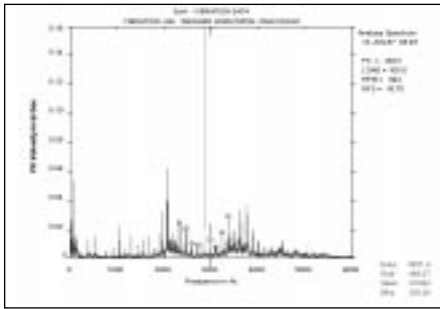
Figure 21. Vibration data acquired while process ran at 944 RPM

of data taken. The vibration data acquired on the inboard bearing, shown in Figure 21, shows the mound of energy in the upper frequency range with BPFO sidebands. The outboard vibration data acquired on the outboard bearing still showed nothing.

The bearings couldn't be examined since they had welded together. After this last failure, spherical roller bearings were put back in, but the outboard bearing was insulated, and the bearing lubrication type was changed.

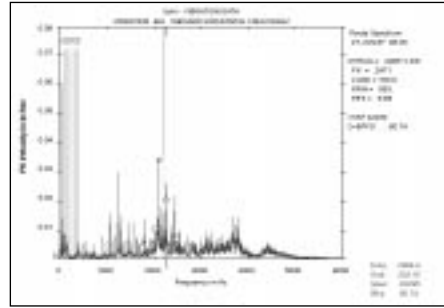
Figure 23. Vibration data acquired on inboard bearing while process ran under no load at 592 RPM

Concern over the repeatability of the data between the two speed and load processes prompted another set of data to be acquired about two weeks later. This time the motor was run at a speed a little above the first process speed, but had to be run under no load. This time the vibration data acquired on both the inboard and outboard bearings show indications of fluting, as shown in Figures 23 and 24.

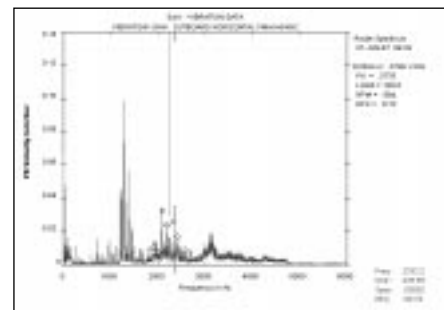
Figure 24. Vibration data acquired on outboard bearing while process ran under no load at 592 RPM

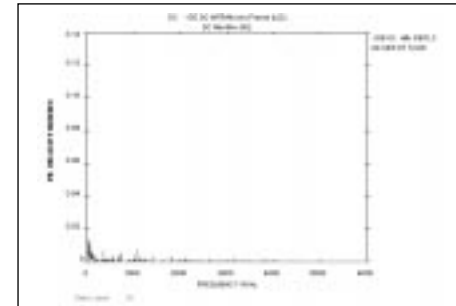
Figure 26. Vibration data after motor replacement

This motor was replaced with one that has a shaft grounding system installed on it. Figure 26 shows no EDM present since the mound of energy present in the 2000 - 4000 Hz range doesn't have BPFO or BPF1 sidebands.

The operator says this motor sounds a lot better than the one it replaced, and upon visual inspection, both the inboard and outboard bearings showed signs of fluting. Remember, the outboard bearing was insulated; therefore, it either was not insulated properly or something occurred that caused the bearing to become shorted to ground. One possible answer for this motor's problems could be a carbon buildup inside of the motor. Further investigation found that the motor's air intake is next to the plant's carbon dust exhaust and was sucking up carbon dust. They are currently working on a solution for this.
